# The GTAW top 10

How to identify and remedy common GTAW mistakes

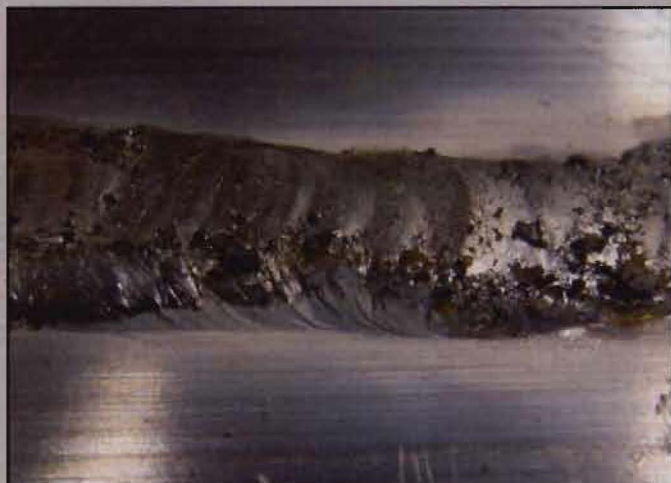
**FIGURE 1**

*This GTAW is the result of poor gas coverage, which can be caused by a number of factors.*

Contamination may be caused by lack of shielding gas, which can happen when the shielding gas is not turned on; if there is either too little or too much gas shielding; or if the gas shielding is blown away (see **Figure 1**).

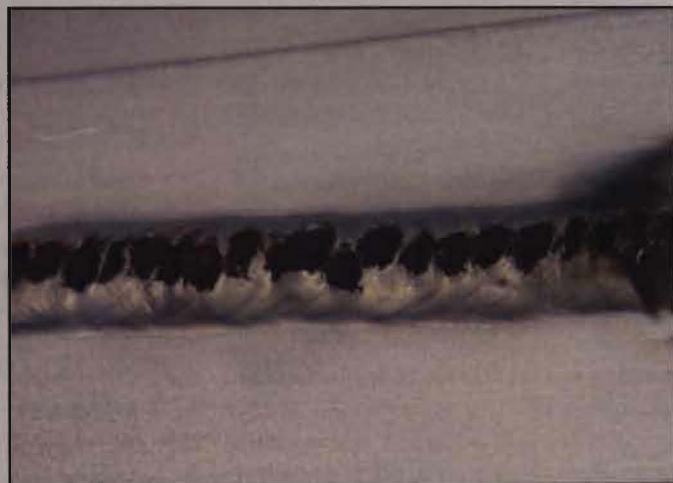
**FIGURE 2**

*Always weld with the polarity set to alternating current.*

The GTAW in **Figure 2** was created with the machine's polarity set on direct current electrode negative (DCEN). As you can see, the weld did not break through the aluminum oxide layer. This created a weld with the filler metal mixed in with the partially melted oxide to create the contaminated bead seen here. To defeat this, always weld with the polarity set to alternating current (AC).

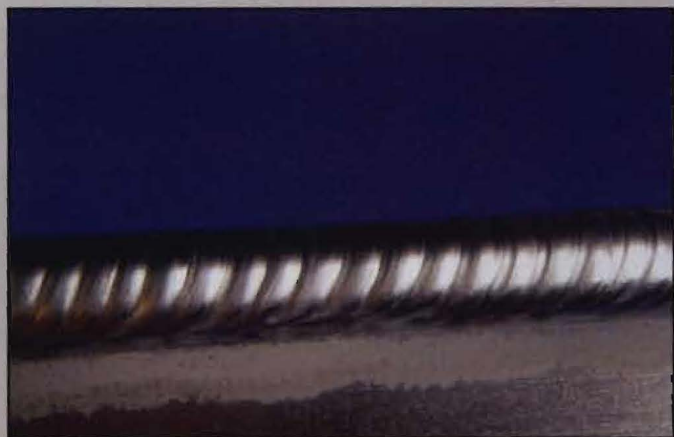
**FIGURE 3**

*Using alternating current produces an ideal GTAW.*

GTAW in AC allows the electrode positive (EP) portion of the cycle to blast away the aluminum oxide while the electrode negative (EN) portion melts the base metal (see **Figure 3**). A feature called AC balance control allows you to tailor the EP-to-EN

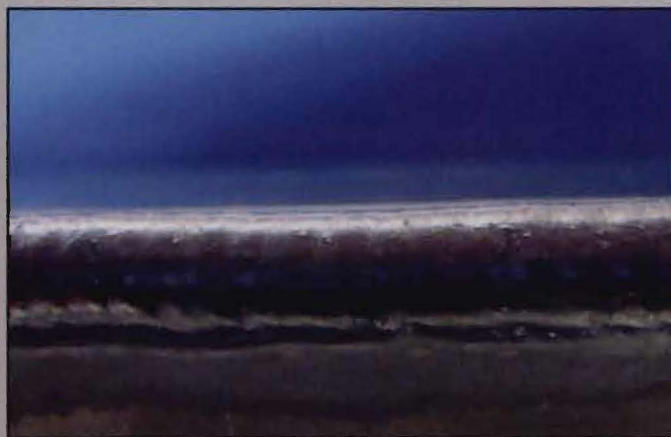
**FIGURE 4**

*The grainy appearance of this GTAW bead was probably caused by a problem with the filler metal.*

A GTAW bead with a grainy appearance typically is caused by filler metal problems (see **Figure 4**). For instance, a 4043

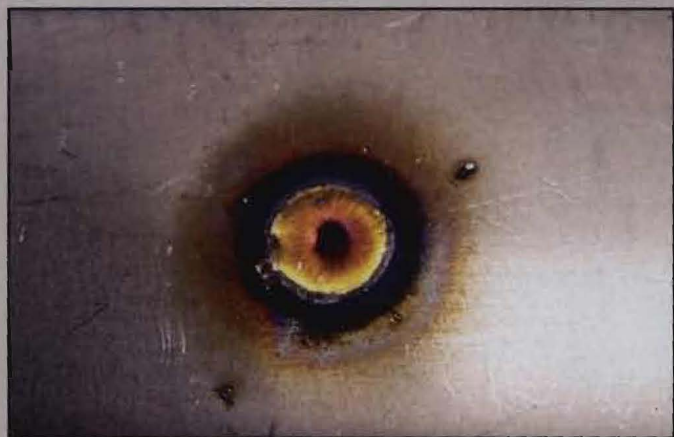
**FIGURE 5**

*To eliminate craters, continue to feed the filler rod and slowly reduce the current at the end of the weld.*

Craters, such as the one shown in **Figure 5**, typically occur at the end of the weld and often lead to cracking. Causes include instantly reducing the welding power, which causes the puddle to cool too quickly, and removing the filler rod too quickly at the end of the weld. You can fix crater cracking issues easily by continuing to feed filler rod while slowly reducing current at the end of a weld. Note that some GTAW power sources feature a crater control function that automatically reduces the current at the end of a weld.

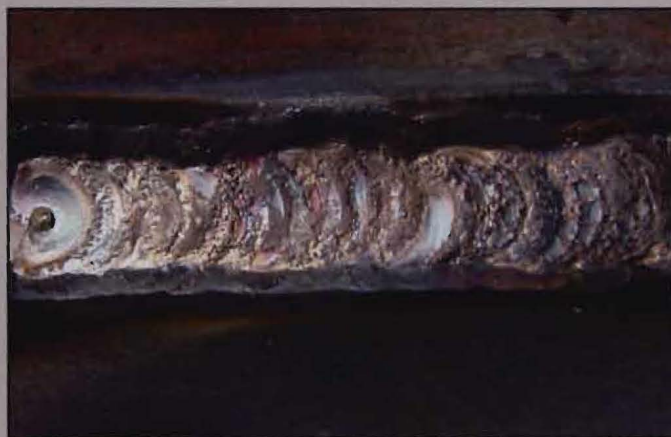
**FIGURE 6**

*When you don't clean the mill scale off of hot-rolled mild steel, this is typically the end result.*

On the first day of welding school, your instructor should have taught you to clean materials prior to welding (see **Figure 6**). All base and filler metals need to be cleaned, whether it's mill scale, oxide on aluminum, or dirt and grease on filler metals. Grind, brush, and wipe away all potential contaminants. For cleaning aluminum, dedicate a stainless steel brush to the task to prevent contamination from other metals (see **Figure 7**).

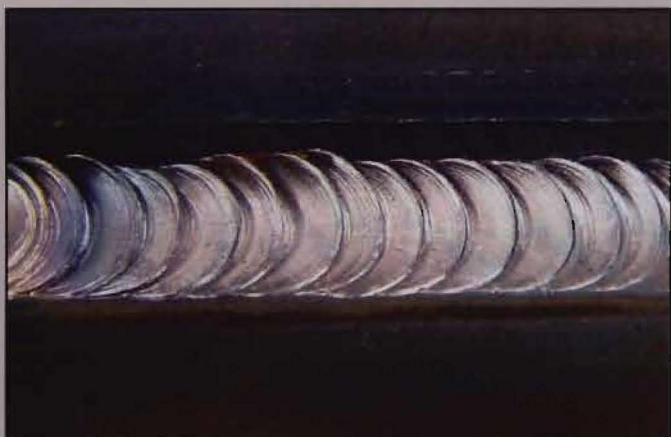
**FIGURE 7**

*Properly cleaned mild steel yields a bead that resembles a stack of dimes.*

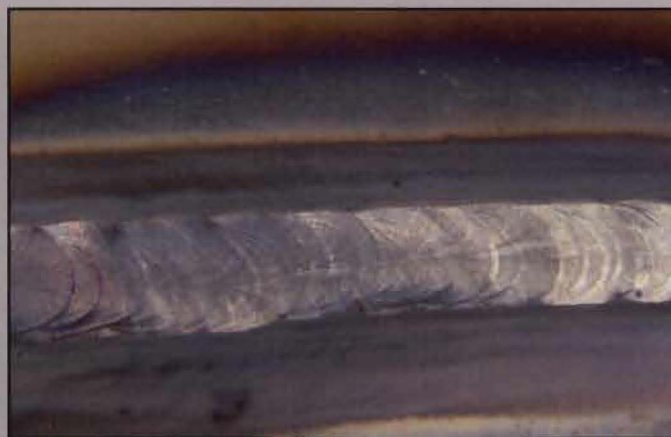
**FIGURE 8**

*The discoloration in this stainless steel weld is caused by overheating, which weakens corrosion resistance and mechanical properties.*

Discoloration on a stainless steel weld is caused by overheating, which not only affects a material's color, but degrades its corrosion resistance and mechanical properties as well (see **Figure 8**). Unfortunately, once this error is made, there is nothing that can be done to fix it except for scraping the part and starting over. To prevent overheating, reduce amperage, slightly increase travel speed, or shorten the arc length (see **Figure 9**). If your welding

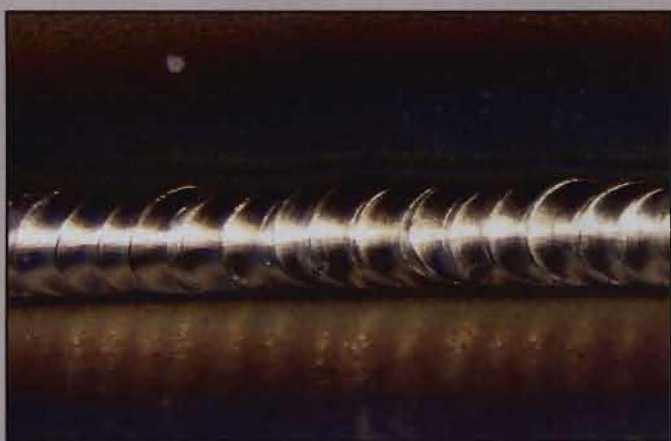
**FIGURE 9**

*Reducing amperage and increasing travel speed will help avoid overheating and produce good weld color on stainless.*

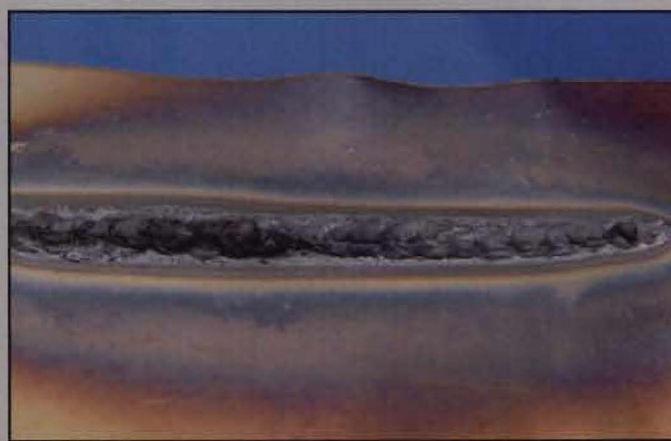
**FIGURE 10**

*To prevent sugaring, backpurge the weld with argon shielding gas or reduce the welding amperage.*

**Figure 10** shows sugaring on the back side of a stainless steel weld. Sugaring (oxidation) occurs around the weld when it is exposed to oxygen in the air. The best way to prevent sugaring is to backpurge the weld with argon shielding gas or reduce welding amperage.

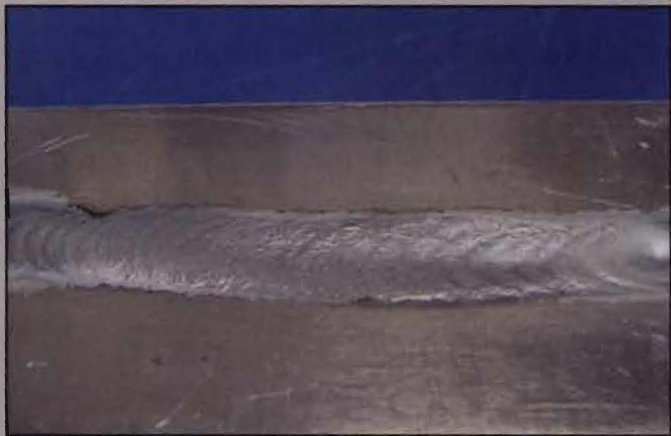
**FIGURE 11**

*If the amperage is set too high with aluminum, the result is an ill-defined bead, which could lead to burn-through.*

Setting the amperage too high when performing aluminum GTAW creates a wider profile, an ill-defined bead, and can potentially lead to burn-through (see **Figure 11**). To solve this problem, reduce amperage and increase travel speed.

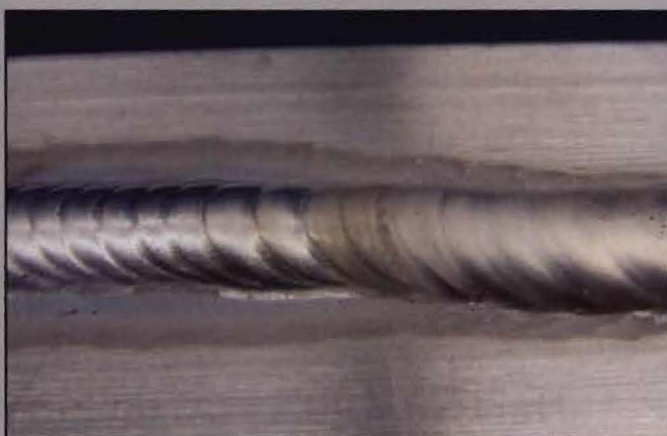
**FIGURE 12**

*A discoloration within the bead is a result of an increased arc length. Practice holding a consistent arc length to improve heat input control.*

The color change in the middle of the aluminum weld bead in **Figure 12** resulted from an increase in arc length (arc length, the distance between the electrode and the base metal, determines GTAW voltage). Holding an arc that is too long increases overall heat input, increases the potential for

distortion, widens the weld bead while decreasing penetration, and affects weld bead appearance. Practice holding a consistent arc length to improve heat input control and improve weld bead quality. ■
